ADVANCED FUEL SYSTEMS FOR RAMJET-POWERED VEHICLES.

TECHNICAL PERFORMANCE STATUS REPORT NO. 2,

1 August 1969

Atlantic Research Corporation
A Division of The Susquehanna Corporation
Alexandria, Virginia

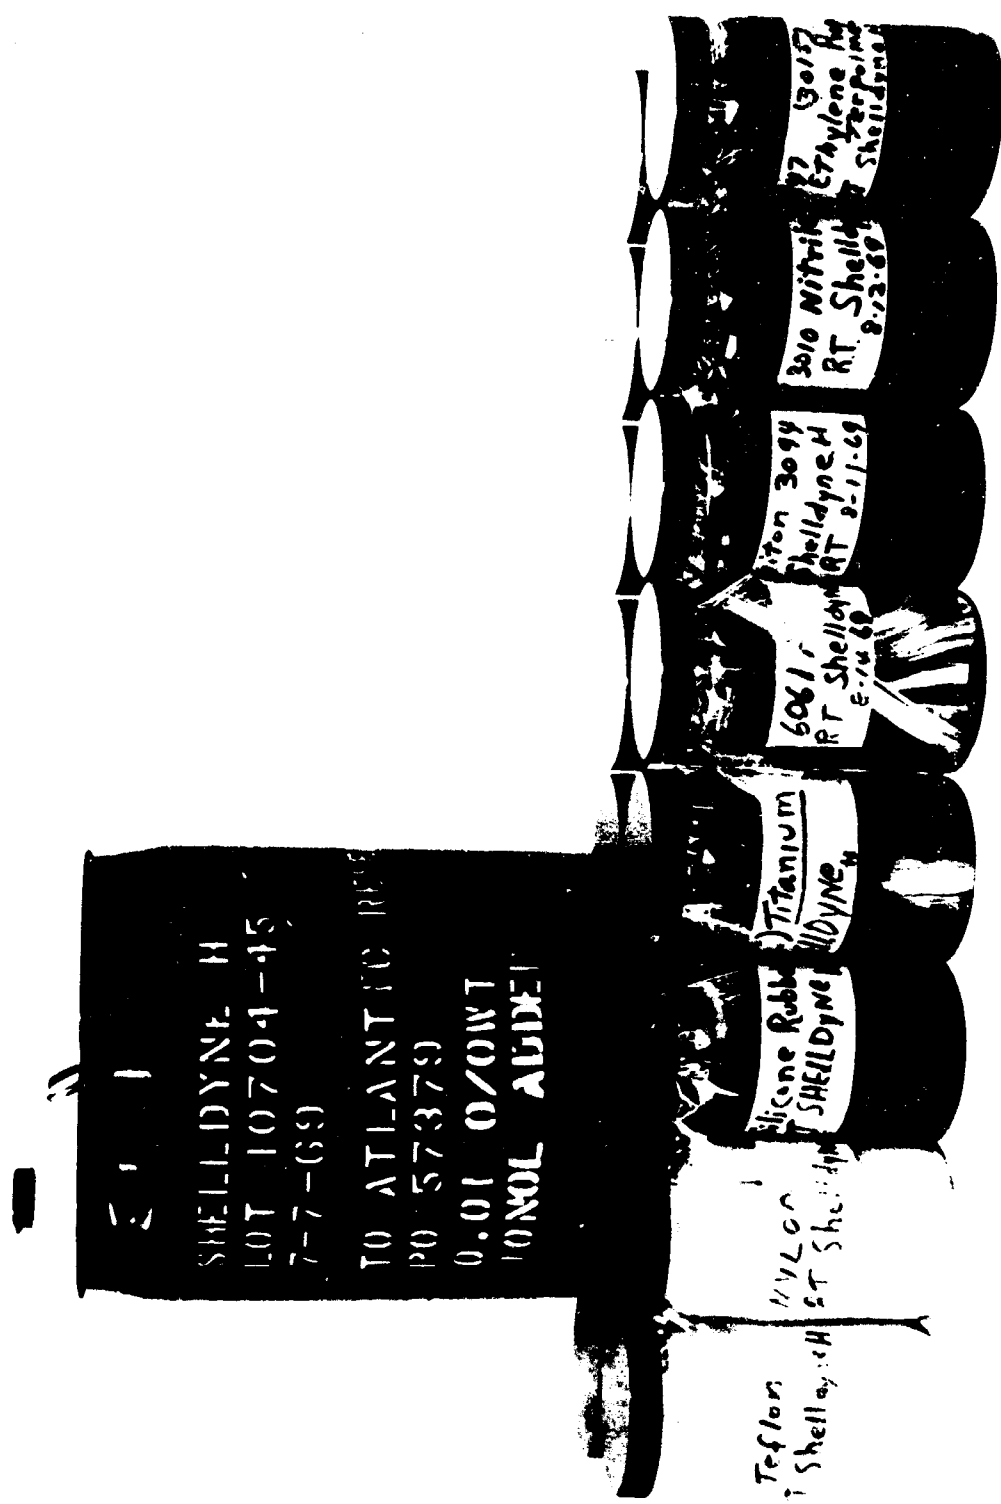
Figure 2.2. Room Temperature Immersion Tests.

The attached photographs (Figures 2.2 and 2.3) show the immersed samples at room temperature.

The initial screening phase of Task I includes the visual examination of both the specimen and the fuel at two week intervals. The fuel, both at room temperature and at 160°F, has been heavily discolored to yellow by the ethylene propylene terpolymer and lightly discolored by the nitrile, the nitrile/nylon, the viton and the viton/nomex. Rust has attacked both the 4130 steel control coupons at room temperature and room temperature Shelldyne H. No rust can be seen on the 4130 coupons in 160°F Shelldyne.

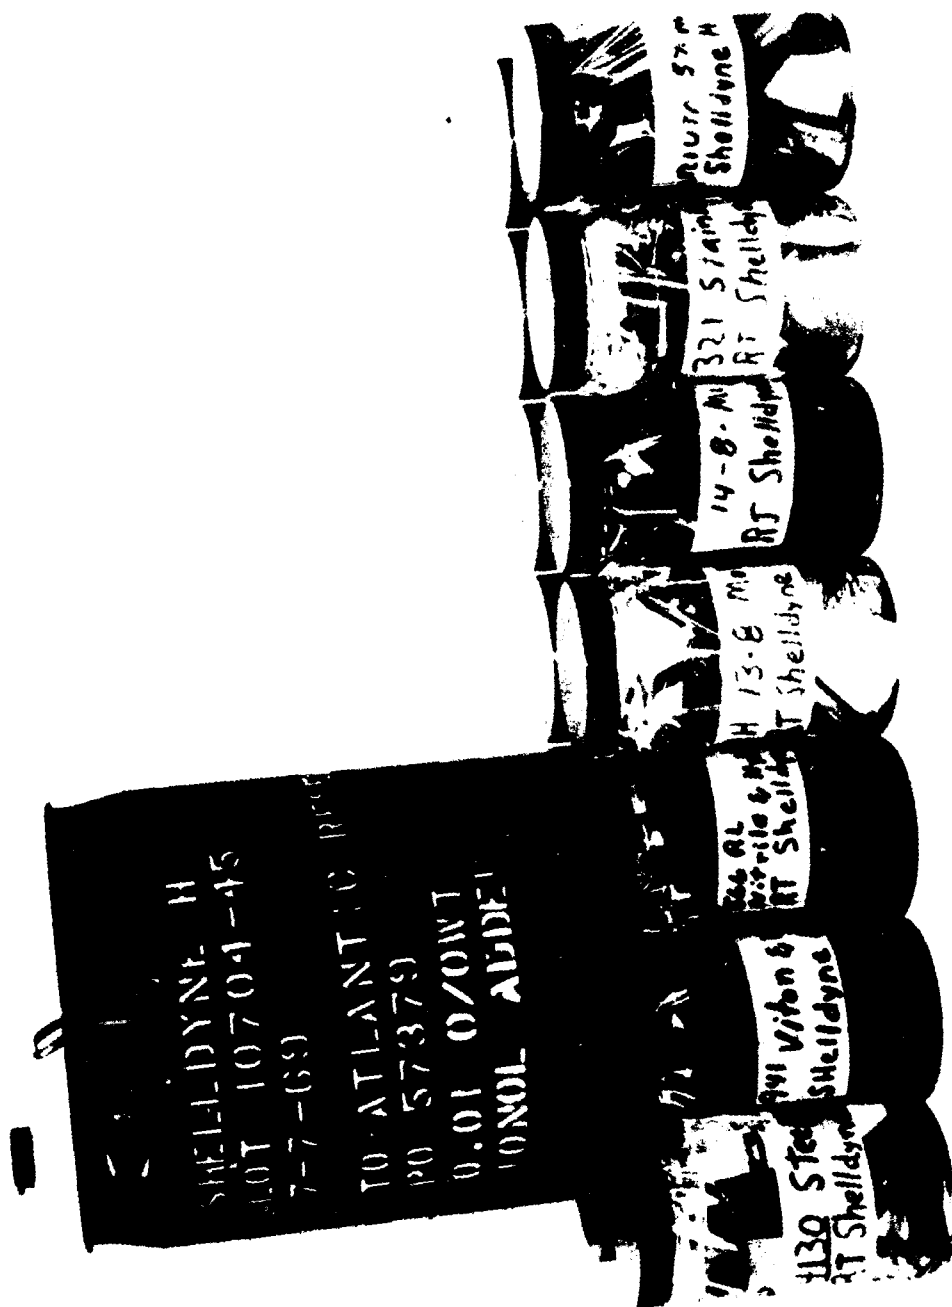
Figure 2.3. Room Temperature Immersion Tests.
